The September 19th, 2017 Puebla, Mexico Earthquake – Preliminary report

S. Roeslin & K.J. Elwood

ABSTRACT

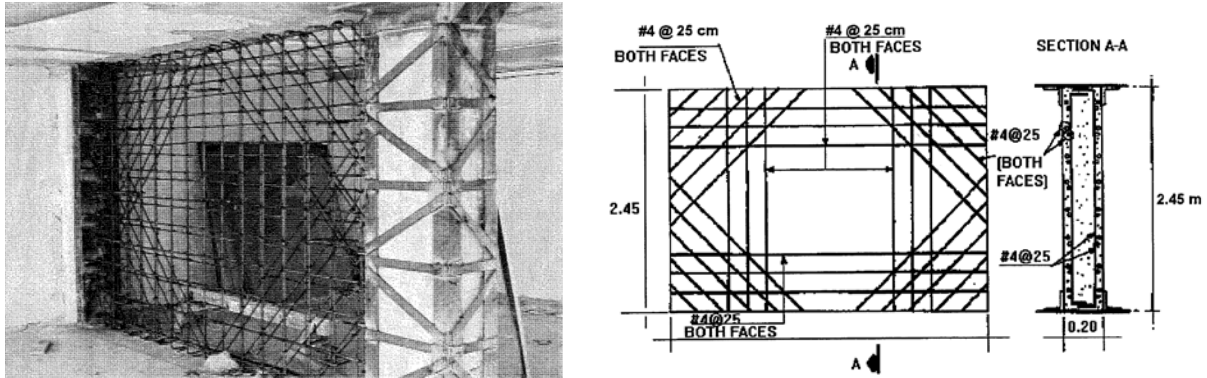
In October 2017, the NZSEE team assessed the performance of retrofitted buildings. Internal inspections were possible for the building G (Aguilar et al., 1996) and the school complex of Colegio Madrid. Figure 7 shows the assessment of a retrofitted wall and column from the building G. No apparent damage was observable. Further details for each case study are available in the full report. Overall, the retrofitted buildings performed well during the 2017 Puebla earthquake.

Figure 7: Wall reinforcement and column jacketing in Z251 (left), details of the retrofit (right) (Aguilar et al., 1996)

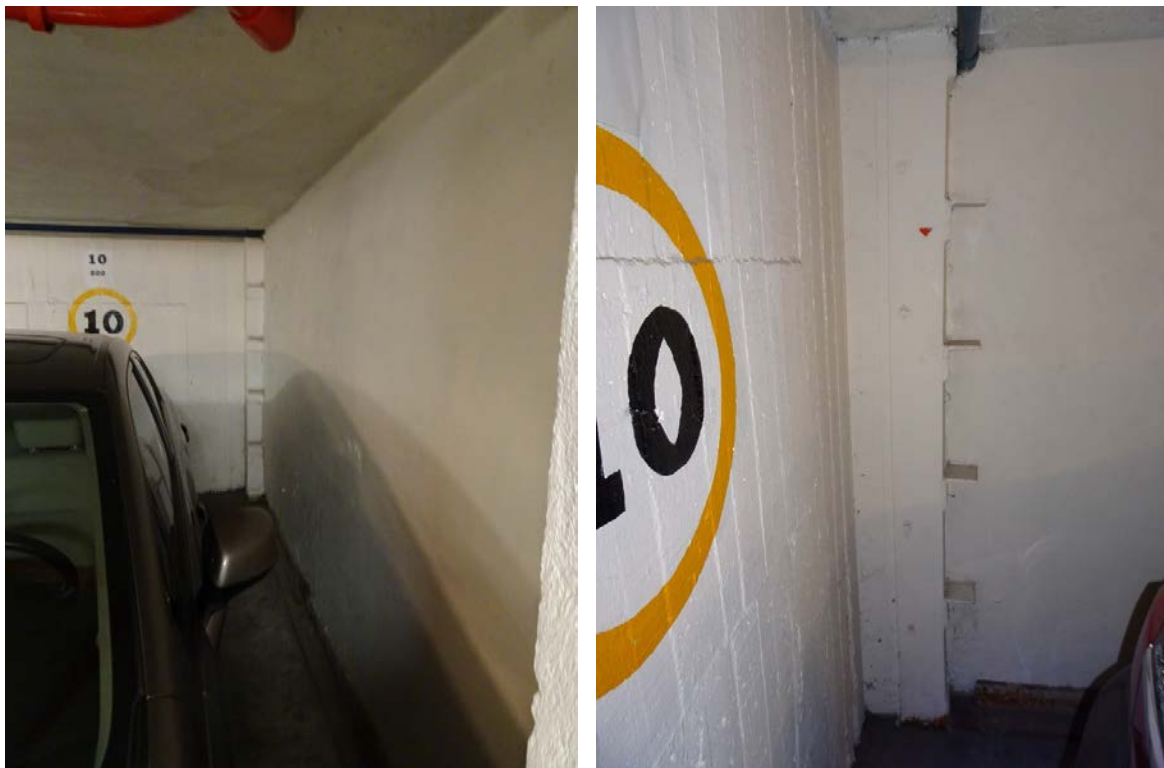
Figure 8: Retrofitted wall in 2017 (left), Steel connection (right)
